Report No.: B24110149  
Date Reported: 11/22/2024  
P.O. No.: Verbal-Ben Doyle

## Expert Report

### Rebuttal Arguments Concerning Case No. 324-CV-00410-B

CLEBURNE TRAINING AND FITNESS CENTER

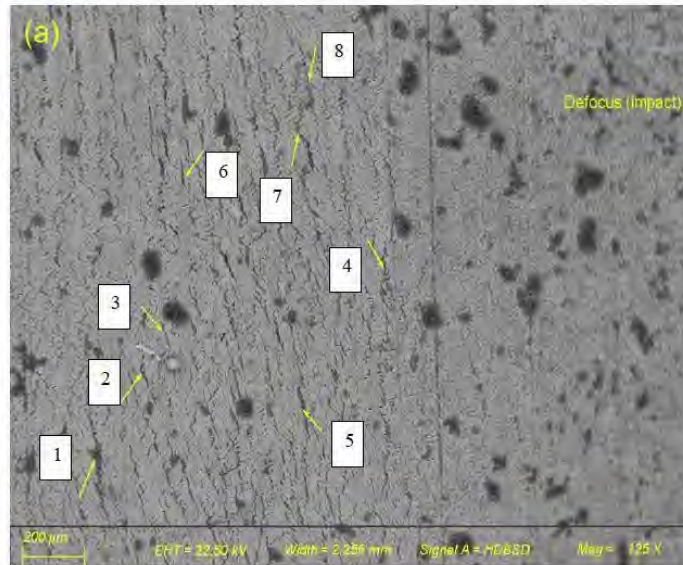
**Figure 1:** SEM image shown in the Dutton report, page 8, Figure 2.

**3.0.4. OPINION #4:** Figures 2 and 3 in the CHURCH MUTUAL report confirm that Mr. Dutton incorrectly interpreted the SEM data in the Element Report, especially with respect to microcracking. His entire narrative is therefore full of *nonsensical claims*.

On page 8 Mr. Dutton uses the SEM image displayed below (again without permission) and adds yellow arrows to show where he made measurements of micro-crack widths. This is shown in Figure 1 below.

Figure 2. Figure 7a from the Element report used to measure crack widths.

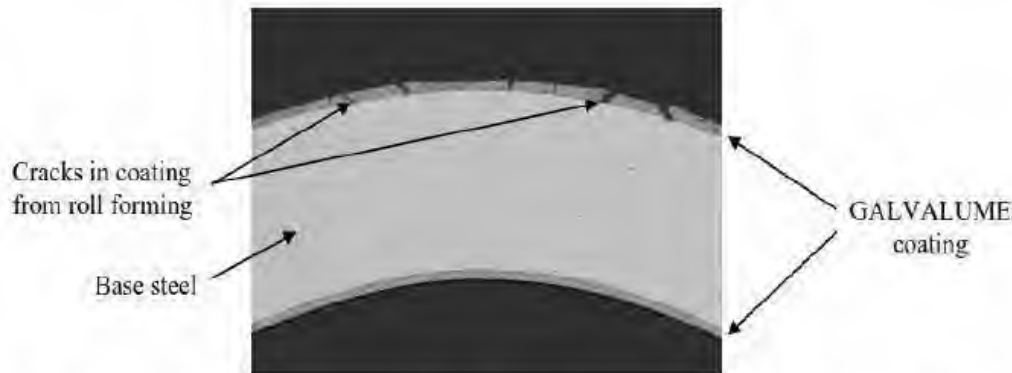
**Figure 2:** Optical image shown in the Dutton report, page 9, Figure 4.

Figure 4. Metallographic cross-section of Denver profile rib radius at 75X magnification.

Mr. Dutton then goes on to use the SEM image of the Cleburn roof micro-cracks and compare them to and optical image of the Denver roof using the information in Figure 2 below. He then claims that micro-crack widths on the Cleburne roof divots somehow confirmed age based on the micro-cracks shown in Figure 2 optically. First of all, Mr. Dutton completely missed the fact

that microcracking at hail damage points on the Cleburne roof *was bi-axial with crisscross cracks* fully within the impact zones and *these are most consistent with point impact on the surface of a plate*. In Figure 2, Mr. Dutton then took a *uniaxial sample in bending* as a basis of comparison to the damage on the Cleburne roof. Based upon these facts, the Dutton report in essence fully misrepresented the Cleburne divot SEM image microcracks; arbitrarily took them to be uniaxial, and then compared these to a bi-axial situation to somehow say the divots are very old. The entire basis of the micro-cracking narrative in terms of divot age is therefore *fully incorrect* and essentially compares apples to oranges with zero testing data to support claims made therein. There can be zero confidence in the Dutton reports comparative analysis of any of the SEM data contained in the Element report.
